# Manhole Inspection Summary

Manhole # S17M\_\_013MH

Insp Date: **5/7/09 9:55 AM**

**Location** Address: **2502 DULANY ST**

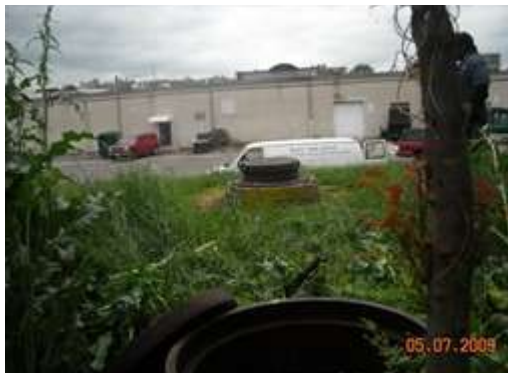
Location View

Comments **CLEARED BRUSH FROM AROUND MANHOLE; CLEANED FROM DOWNSTREAM MANHOLE S17M\_\_012MH FOR 1 HOUR - 2 PASSES, UNABLE TO LOCATE DOWNSTREAM MANHOLE S17M\_\_024MH; STRUCTURE IS ON GRADE WITH FRAME ABOVE.**
